## Jumper Creek Bridge Replacement

In 2007, the Florida Department of Transportation (FDOT) conducted a biannual inspection of the bridge that conveyed Sumter County Road 311W (CR 311W) over Jumper Creek. The inspection revealed significant deterioration of the bridge's substructure and deck, and it was tagged as structurally deficient. As such, it was programmed for replacement by FDOT in 2011.

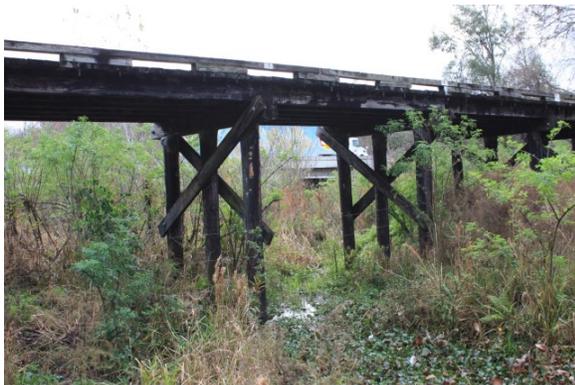
About ½-mile south of where CR 311W crosses beneath I-75, the road was conveyed over Jumper Creek by a one-lane, timber bridge. The bridge was built in 1960, had a total length of 212 feet, and provided 11 feet of clear width from curb to curb. The original structure had timber piles, timber decking, and a 6-inch high timber curb.

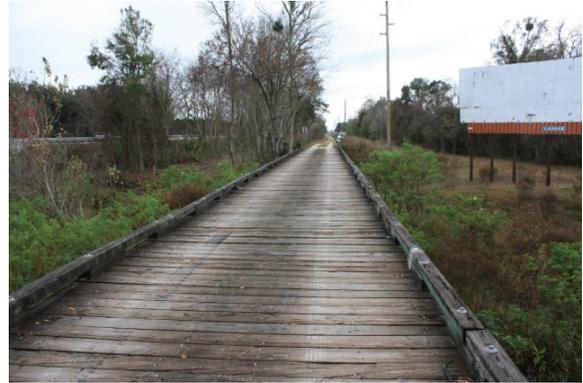
Standard FDOT bridge design would have replaced the existing bridge with a new concrete and steel structure. In addition, full implementation of FDOT roadway standards would have required two 12-foot lanes with 8-foot outside shoulders. Barrier walls would also have been required along the outside of the new structure to keep errant vehicles from falling off the bridge.

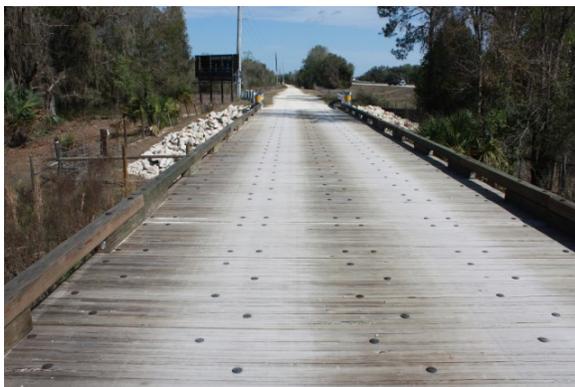
The bridge deck, however, was constructed using glued laminated timber (glulam). By using glulam to construct the bridge deck, FDOT was able to save up-front construction costs over a much costlier concrete and steel alternative. Also, the look of the timber preserved the rural feel of the area and was met with much enthusiasm by the road users.

The bridge materials were also identified as a potential Context Sensitive Solution. Instead of constructing the new bridge entirely of concrete and steel, the new structure incorporates timber as well. The substructure consists of steel piles and concrete pile caps. These elements are not easily visible and are not considered to intrude on the rural character of the area. Because of the durability of the concrete and steel, the bridge substructure should remain in place for 75-100 years.

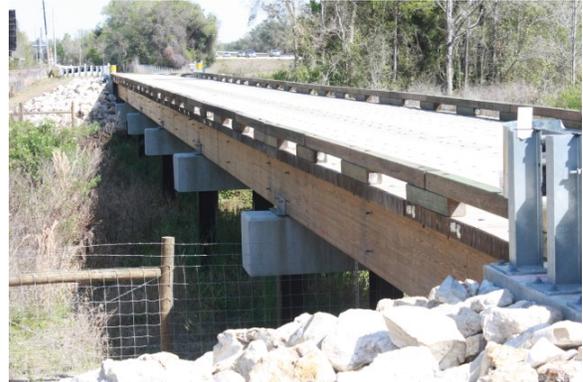
In addition to maintaining a one-lane bridge typical section and using timber as a construction material, the new bridge eschewed the use of barrier wall. In this case, the old bridge had been in place for nearly 50 years without any recorded incidents where an errant vehicle drove off the bridge. As a mix between CSS and Practical Design, the design team decided to replace the existing timber curb in-kind on the new structure. This approach not only saved money on barrier wall construction,

but it also helped to preserve the character of the area.
