NEW MEXICO STATE ROAD 14 FROM MADRID TO LONE BUTTE

THE CONTEXT

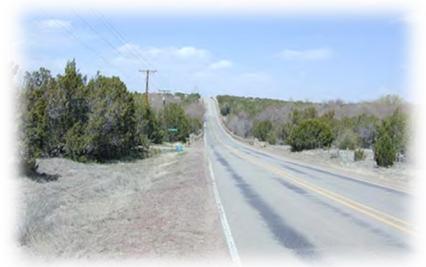
Existing NM 14 and San Maracos
Arroyo Bridge

Existing NM 14 through the corridor was a two-lane highway with narrow or no paved shoulders. The existing pavement and subgrade were exhibiting signs of severe deterioration. Three bridge structures were also in need of replacement. The portion of NM 14 within the project limits had a relatively high number of crashes that were clustered in areas with sharp curves and/or limited sight distance.
